Auxiliary Joint Surface/Air Operation

Saturday 25 August 2007

After-Action Report

Sector North Carolina
Stations Wrightsville Beach & Oak Island

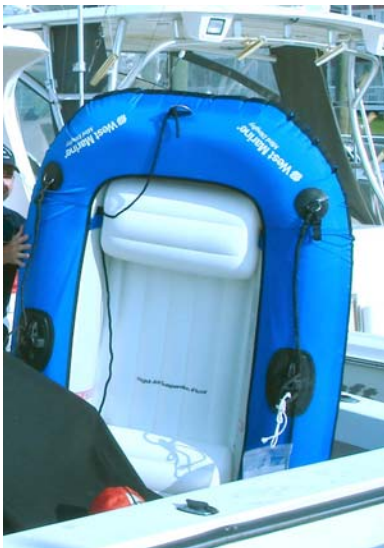
8' inflatable bright blue-hulled inflatable “raft” with a white bottom, below.

“Oscar” was essentially a floating but weighted “Mustang”. Note that this was an **all-orange** target that floats in a prone position with most of its surface area visible. A conscious PIW would float with only a head and perhaps shoulders above the water. An unconscious PIW would float almost awash.

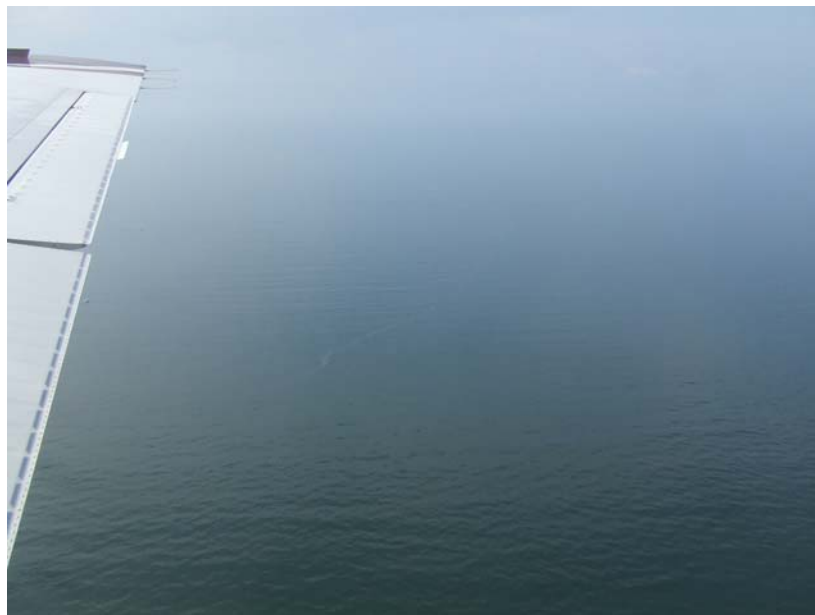
Visibility from the aircraft was remarkably good to the north, as the photos at the reference illustrate. Most were taken without a zoom and are a good representation of what the eye sees. However, this photo below shows visibility toward the south.

Only targets that were very close to the nearest point of observation (depressed angle) from the aircraft could have been seen from the aircraft on its eastward legs. It would be interesting to fashion aircraft patterns that consider atmospheric conditions and sun angle.

Visual search toward the south was very difficult due to haze and glint off the surface of the ocean. Viewing conditions toward the north were excellent. The configuration of the aircraft (twin engine, low wing) restricted search field of view compared to a high-wing aircraft. **35190** was easily visible and identifiable to the aircraft from any location within the search area. In addition, essentially any white-hulled boat was visible, when looking north, in the area west from the mouth of the Cape Fear River, over Station Oak Island to Lockwood's Folly Inlet and then south to the latitude of the **2JHs** CSP.

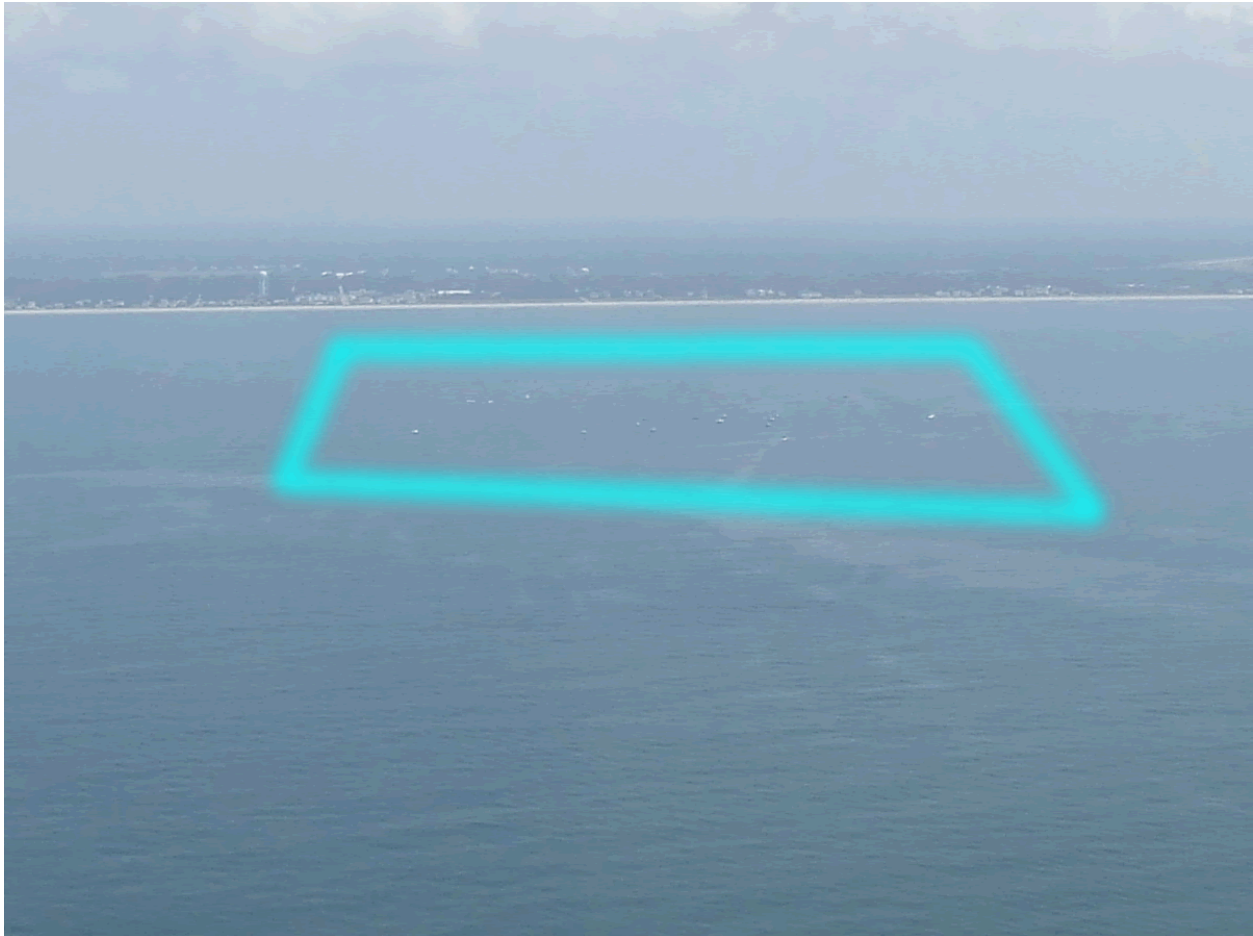
This photo below, by contrast, shows visibility looking to the north. This photo was taken from the first (southernmost) long leg looking to the north. Notice the large number of boats in the area of the Yaupon Beach fish haven.
